## Technical Bulletin #35

DATE: 21 JULY 2006

SUBJECT: **Superscan Housing**

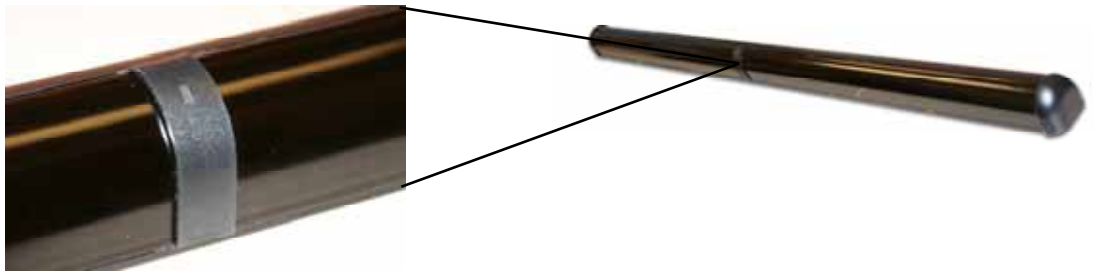
Additional Light Pipe

The sensor you are about to install looks slightly different than the regular BEA SuperScan you are familiar with. Please notice the presence of an additional light pipe in the center of the unit.

There is no known performance issue linked to the presence of this new component – its only purpose is to connect seamlessly the two lenses of the sensor.
